Stone Consulting & Design, P.C.

January 30, 2017

Subject: LBA Scrubber, 13' Dia. x 103' Tall
Tonawanda Coke Corporation Facility
External Inspection

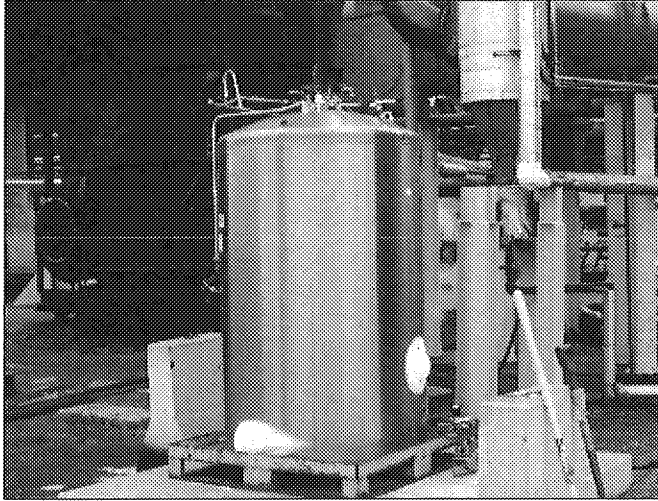
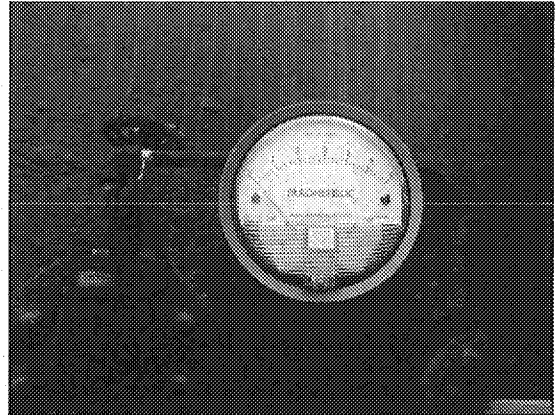
The structure is currently slightly pressurized with nitrogen so no internal inspection could be completed. The purpose of this inspection is to confirm structural integrity as part of the approval process to discontinue the nitrogen pressurization. Although the gage reads "0", the needle is away from the stop and fluctuates slightly, indicating some pressure is present.

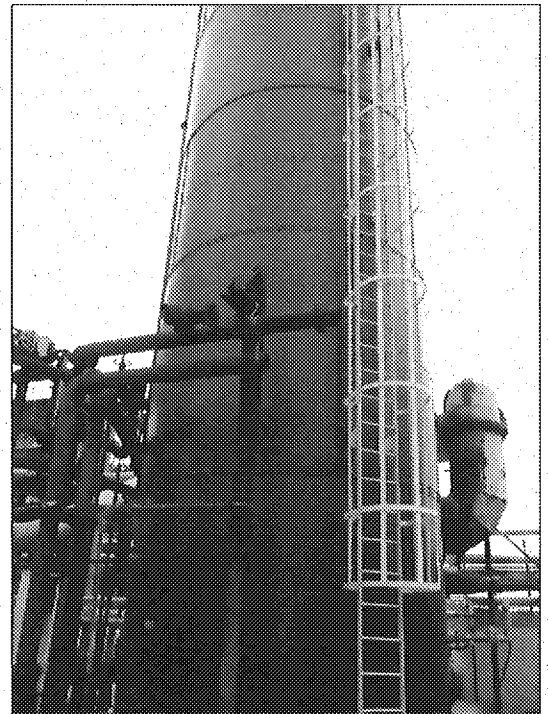
All eight of the perimeter anchor bolts were closely inspected as well as the walls of the structure in the vicinity of the anchor bolts connections. No signs of deterioration or cracking were noted.

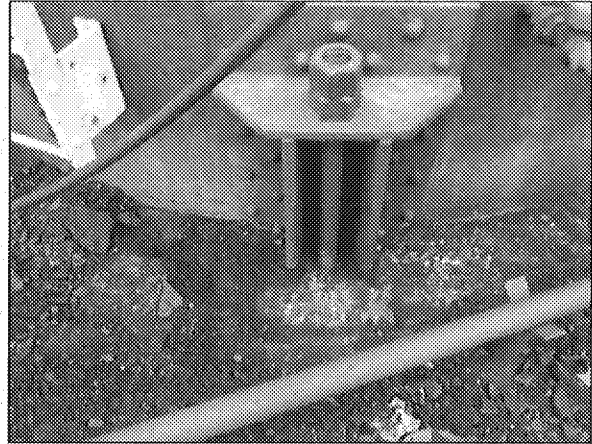
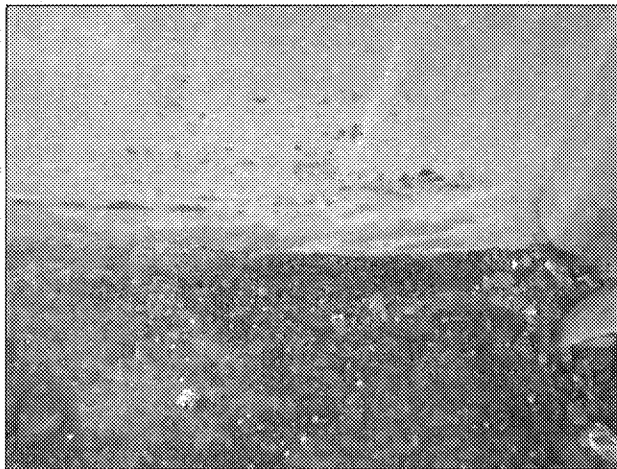
At the ground line, the steel structure transitions to concrete. It would be better if this transition occurred above the ground by 6" to 12", but it does not. Digging and scraping was required to expose the concrete. Only minor corrosion of the buried steel was observed.

The steel plate is $\frac{1}{2}$ " thick here, so the observed corrosion is insignificant. Lowering the ground level around the perimeter and improving the drainage in this area is recommended to prevent corrosion at the base. I recognize the condition I observed in December may not be typical and the drainage may be adequate.

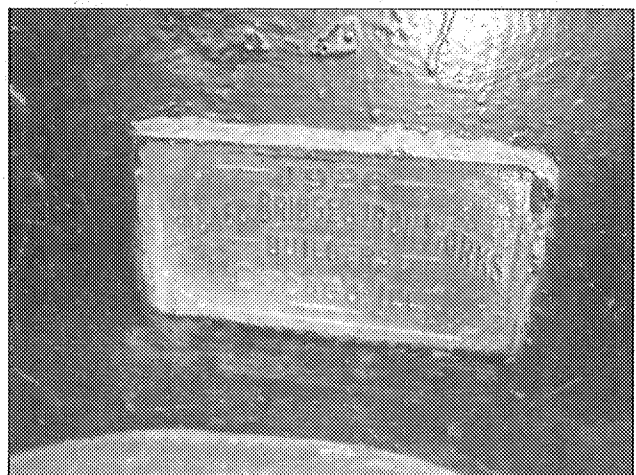
The structure is 90 years old and built in a time when riveted construction was used. A possible problem for this type of construction would be "pack rust" at the lap joints. Two surfaces of overlapping steel are riveted together, and any corrosion between the two surfaces pushes the member apart. This was not observed on the structure,

except for one small location. I only include this photo to illustrate the condition described.

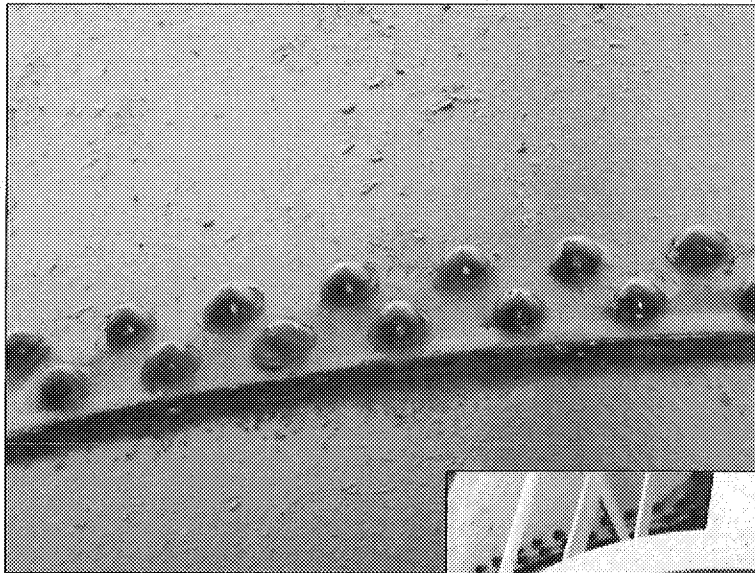
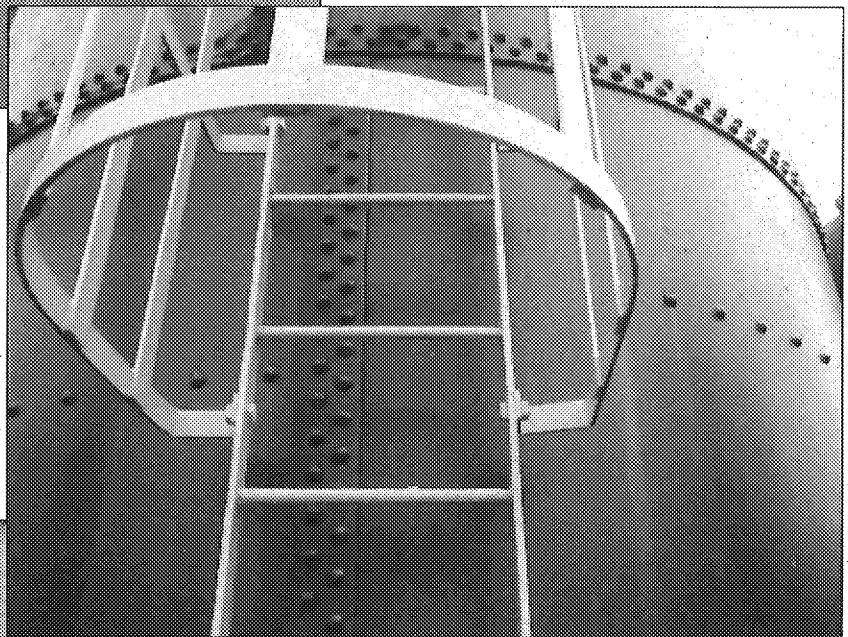
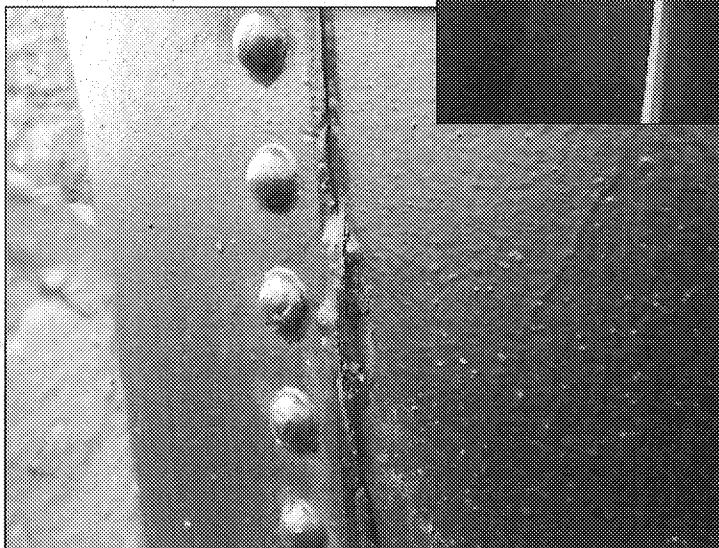
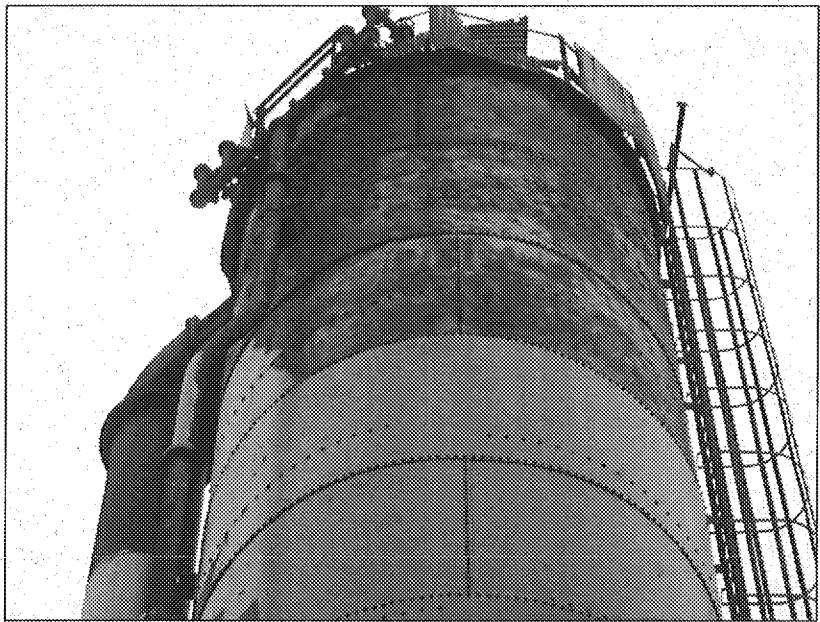
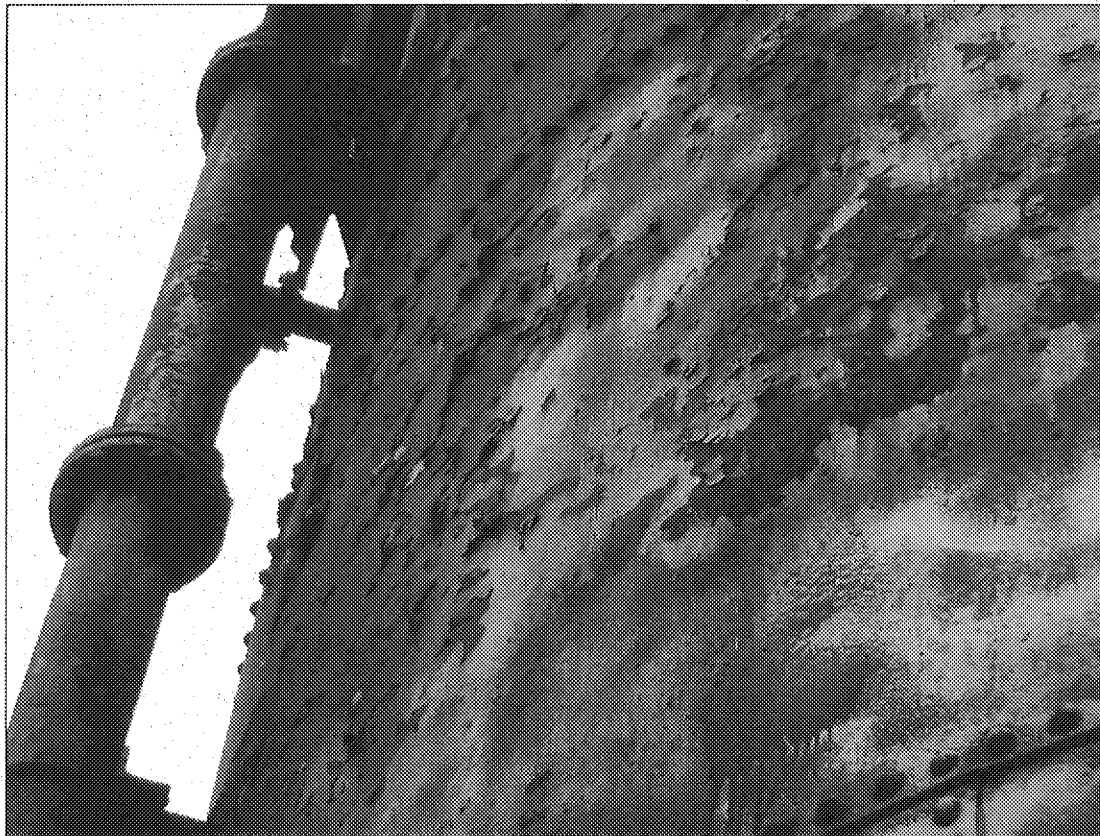
The structure was recently painted, but not all the way to the top. While the more recently painted portions show no corrosion, even the less recently painted areas show only peeling paint and light rust. Near the top, the wall is 5/16" thick steel plate making the observed rust insignificant.
